BUILDING STRUCTURAL CONDITION ASSESSMENT REPORT

RITZ HOTEL HERITAGE BUILDING, ADARSH NAGAR, HYDERABAD

7/28/2017

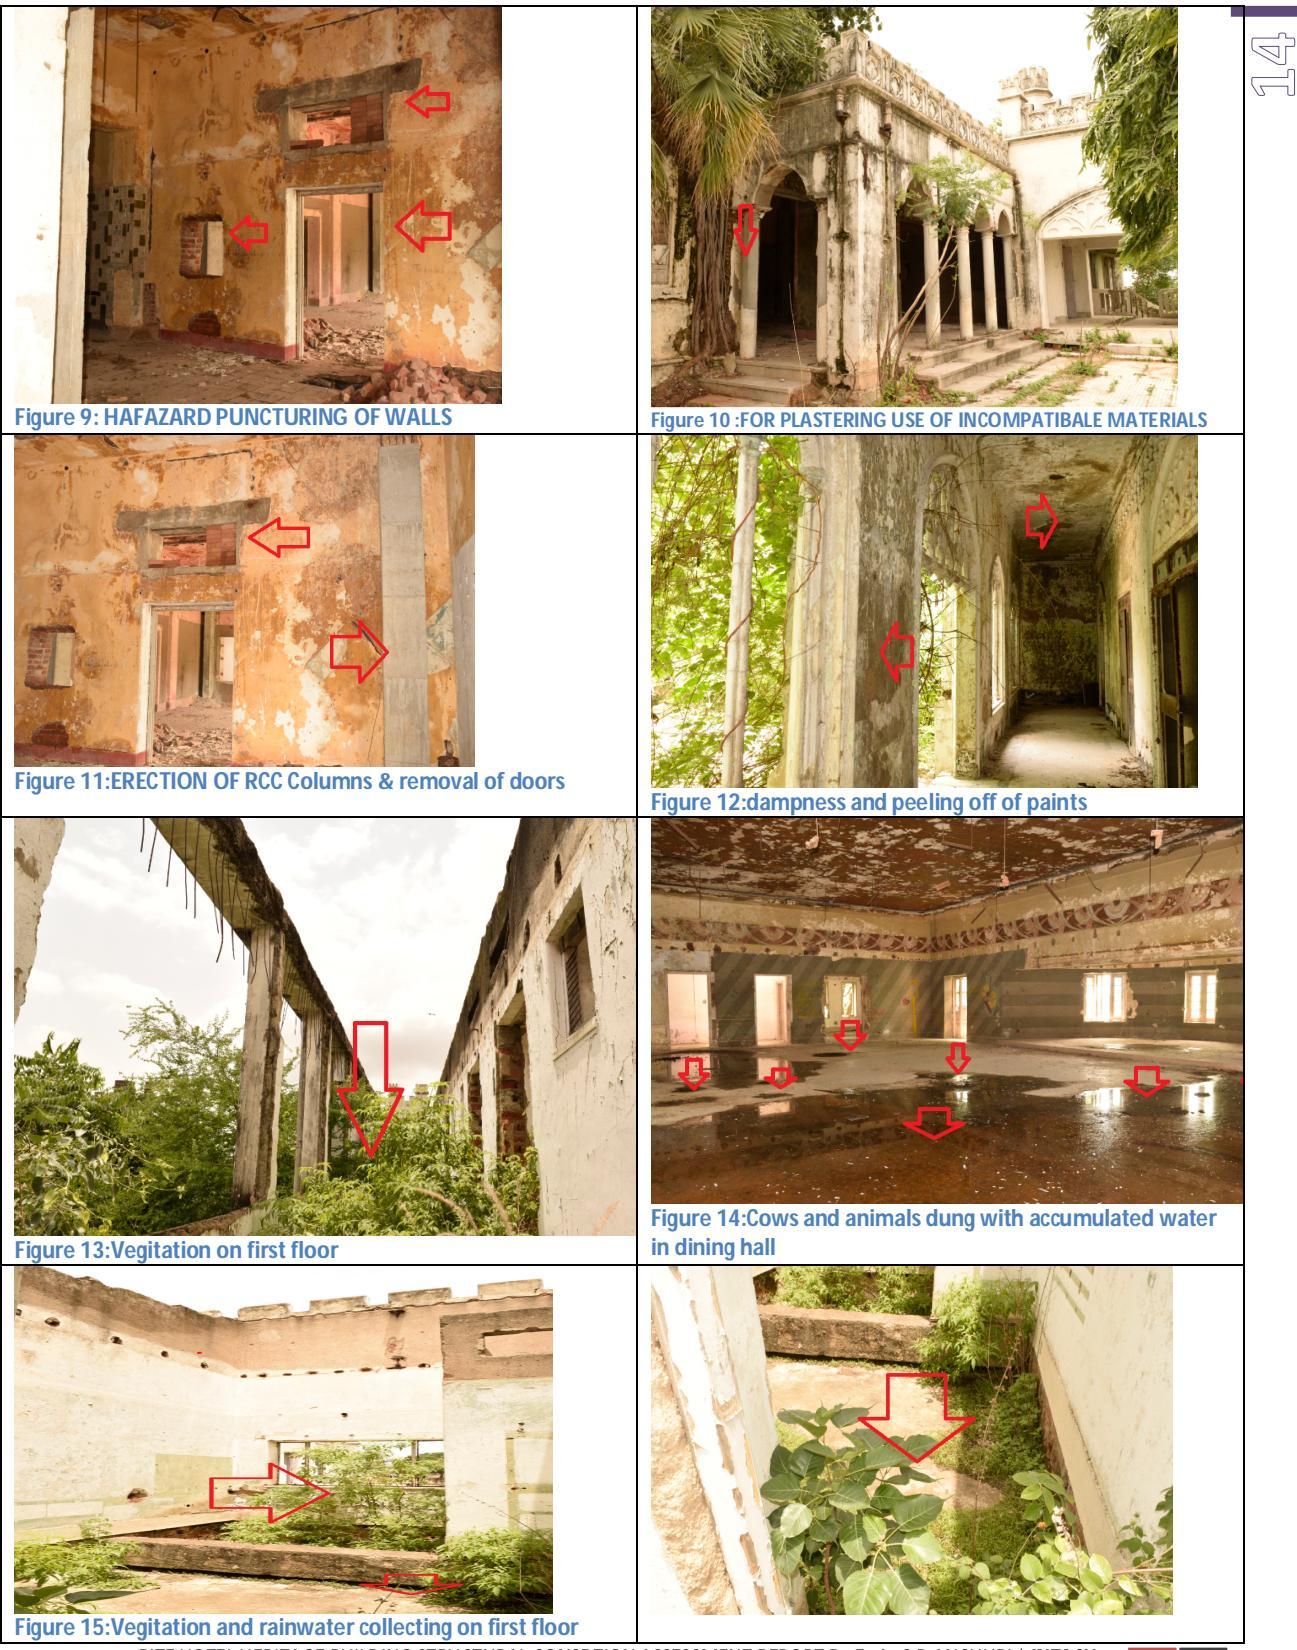
Figure 16:Small and big trees growth on first floor	
	- M
	Ţ
